Descriptive sheet

394 Besserer Street

Phase 2 Evaluation Results

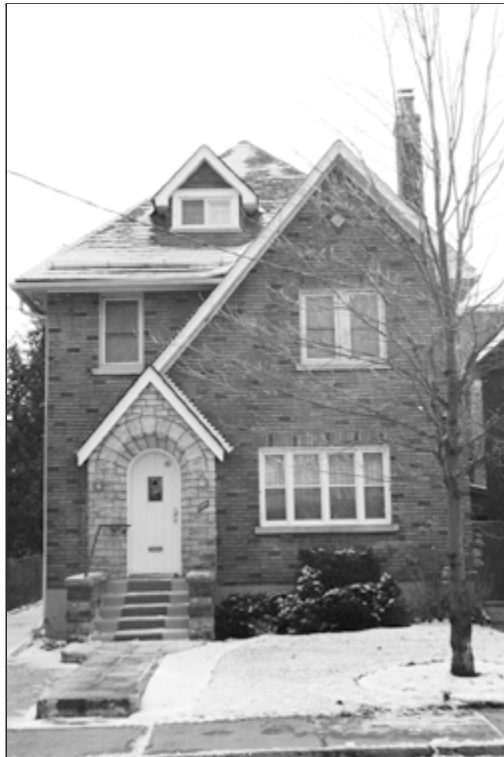
Property characteristics: Single use residential. Detached, 2 1/2 storey with rectangular plan, off-center entry and occupied basement. Site features consist of a driveway, a detached garage and a fence.

Exterior elements: Sloped roof asphalt shingles with asymmetrical gable end towards street.; dormers and 1 brick chimney. Exterior with stone sills, voussoirs, beige brick with red brick inserts and brick and stone medallion in gable end. Parged foundation.

Windows and doors: Rectangular metal double hung 1 x 1 windows and metal rectangular windows at ground floor with leaded glass. Single front door with round arched wood door with window.

Other features: 1 storey stone porch with stone base, stone balustrade, sloped roof and stone arched door surround.

High to medium: non-original windows and roofing materials affect the integrity.

This detached residence is typical of many houses built in the 1930's on this block and in the larger sector of Sandy Hill. It is characterized by its square form with hipped roof and variegated brick. The front facade has an Arts and Crafts stylistic influence with its asymmetrically sloped roof at the gable end and arched front door. These elements should be maintained in future renovations.

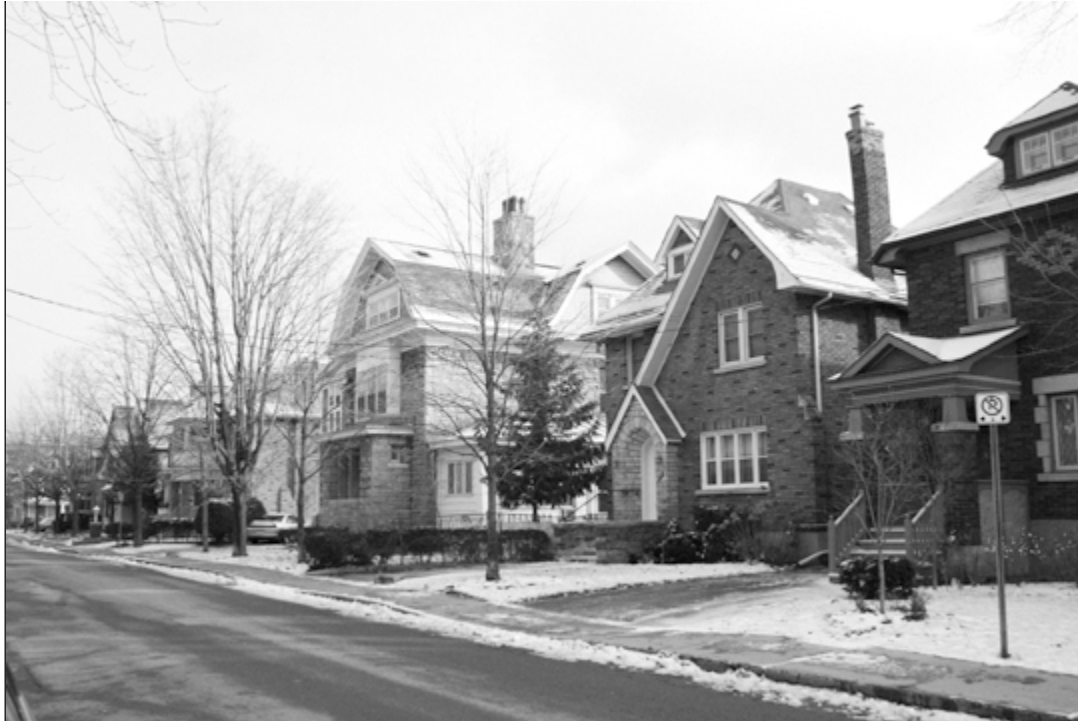
Pattern of site use: Typical front and side set backs
 Use: Typical (residential)
 Height/Volume: Typical
 Materials: Typical (brick, stone)
 Typology: Type 3(p, variation)

This property is compatible with the block in which it sits.
